## Online condition monitoring of rolling stock wheels and axle bearings

# Online condition monitoring of rolling stock wheels and axle bearings

## Abstract

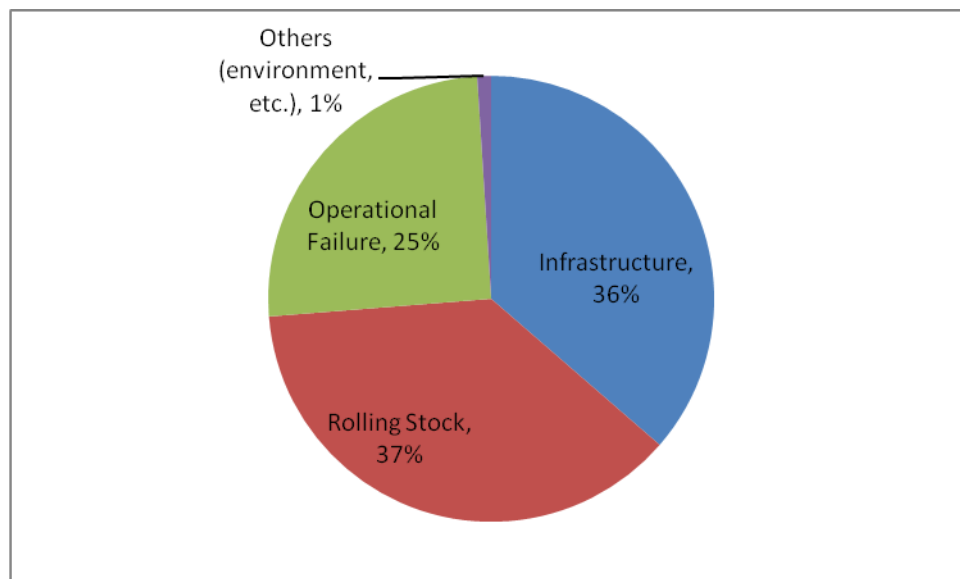
Figure 1: Railway accidents considered in the D-RAIL FP7 project by cause [taken from reference 5].

A recent study published by DNV as part of the D-RAIL FP7 project considered the railway accidents that have been reported in 23 countries over the past years [5]. It was revealed that out of the 700 accidents considered, 37% of them were due to rolling stock faults (figure 1). Moreover, 84% of all rolling stock-related accidents were confirmed to have been caused by wheelset and bogie-related defects (figure 2).

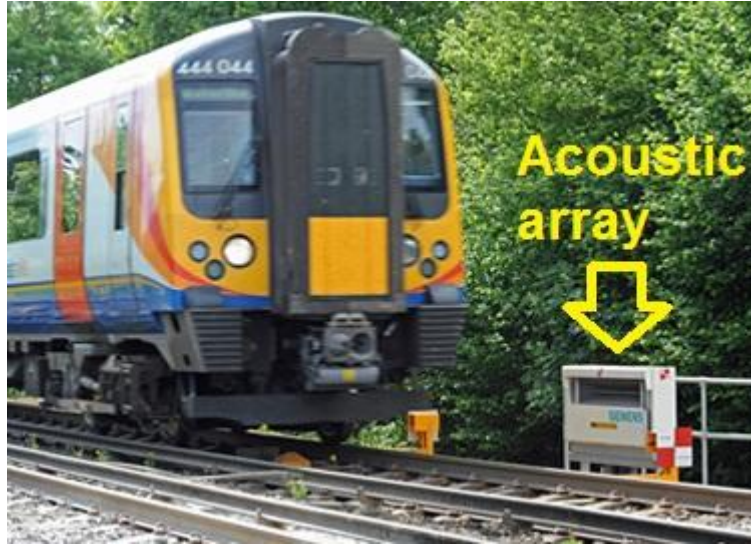
Figure 4: A RailBAM trackside acoustic array detector installed on the British rail network near London (the photograph is courtesy of SIEMENS).

Trackside Acoustic Array Detectors (TAADs) use arrays of microphone to record the noise produced by the bearing. An example of TAADs is shown in figure 4. TAADs are capable of detecting the acoustic signature of early bearing defects using spectral analysis and data trending [10]. The maximum operational frequency range of the microphones used in trackside acoustic arrays is normally 22-44 kHz. At this operating frequency range the microphones can be affected by surrounding environmental noises as well as noises from the measured train itself. Noises from the wheel-rail interface and the train engine can contaminate the signal acquired by the acoustic array possibly resulting in false alarms or missed faults.

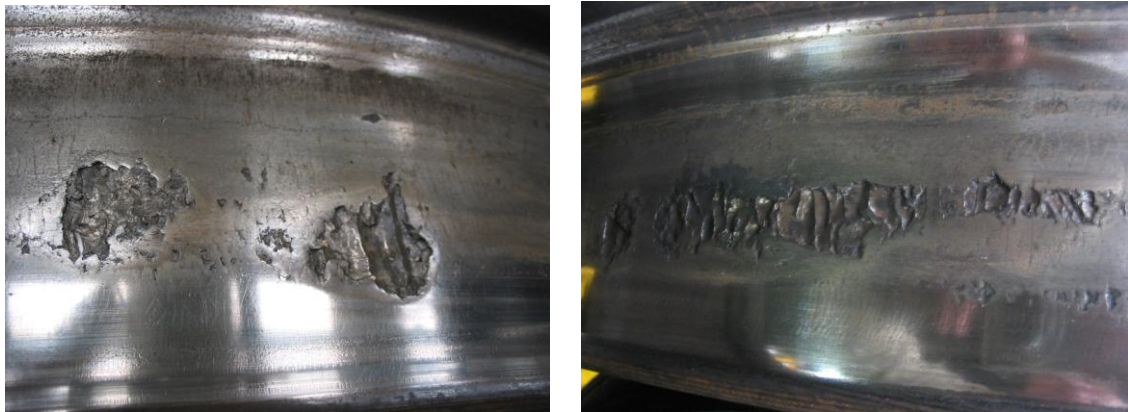
Figure 6: Photographs showing shelling on the tread of the damaged wheel of the EMU tested.

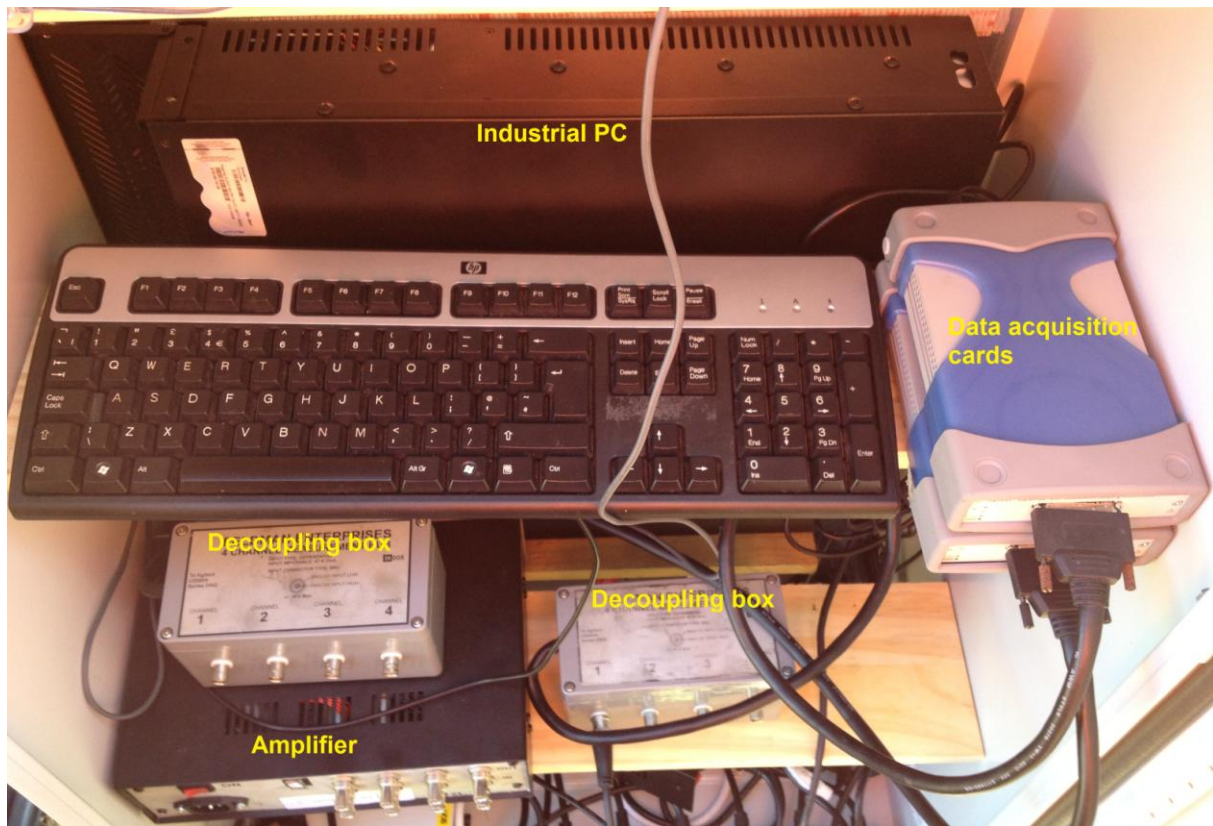
Figure 7: The customised data acquisition equipment used during trials in Long Marston.

The customized AE/vibration analysis system consists of the following components: a) R50A resonant acoustic emission sensors manufactured by Physical Acoustics Corporation (PAC), b) 25kHz high frequency accelerometers with sensitivity 100mV/g manufactured by Wilcoxon, c) pre-amplifiers manufactured by PAC, d) digital amplifiers manufactured by Krestos, e) accelerometer power supply manufactured by Krestos, f) four-channel decoupling hub manufactured by Krestos, g) 2531A Agilent four-channel data acquisition card with a maximum sampling rate of 2 MS/s in single channel mode and h) Amplicon industrial

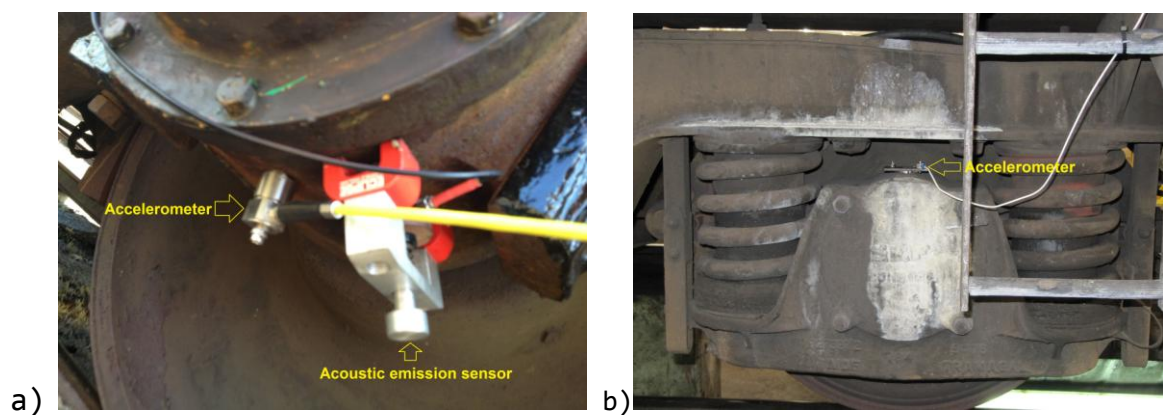
Figure 8: a) AE sensor and accelerometer installed in one of the axle bearing of the tanker freight wagons tested in Long Marston, UK and b) accelerometer installed in one of the two wheels of the EMU tested in Cas-Cais, Portugal.

computer with customised data logging and analysis software developed by the authors. The AE sensors and accelerometers were mounted using magnetic hold-downs as shown in figure 8a.

AE sensors and accelerometers were mounted using magnetic hold-downs. The area where the sensors were mounted was slightly ground to improve contact. Vaseline was used to couple the AE sensors on the surface of the axle bearing casing in order to maximize the transmissibility of ultrasonic waves produced from axle bearing to the piezoelectric sensing element. The acquisition system during testing was triggered manually.

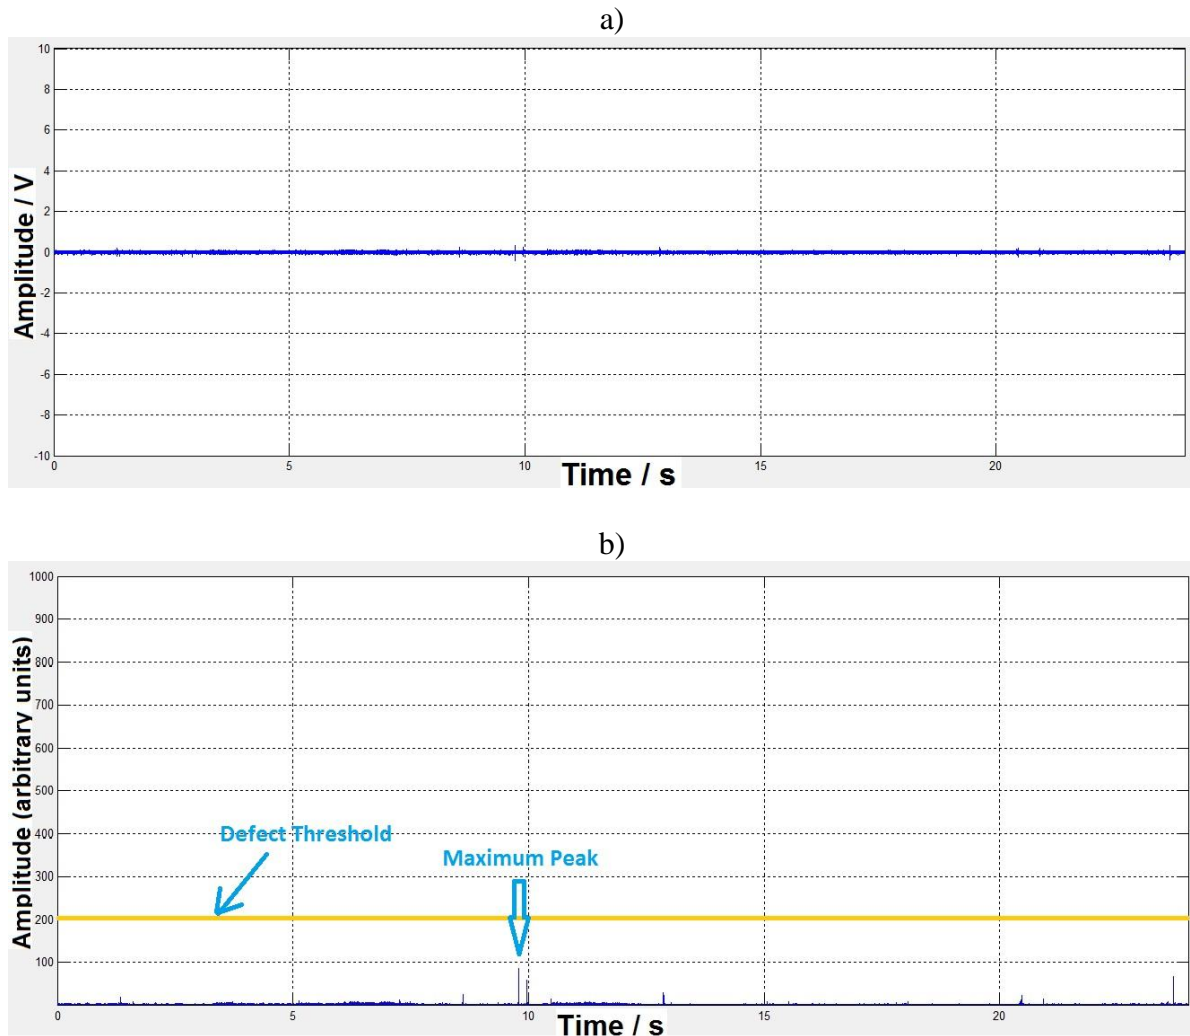
Figure 9: a) Raw AE data acquired from a healthy bearing and b) its moving RMS plot using a filtering time window of 60  $\mu$ s.

Some typical results of bearing defects are listed below from onboard measurements carried out in Long Marston. These tests have been carried out to verify the actual presence of the artificially induced defects and their severity as well as to confirm that the axle bearings considered to be in good condition are indeed healthy. The plot in figure 9a shows the onboard raw AE measurement of a healthy bearing carried out at a speed of 24 km/h. The plot in figure 9b is the normalised moving RMS of the signal filtered using a time window of 60  $\mu$ s. It is evident that the AE signal contains very little noise. This is manifested also in the RMS plot of the raw signal where peaks below 100 arbitrary units are seen.

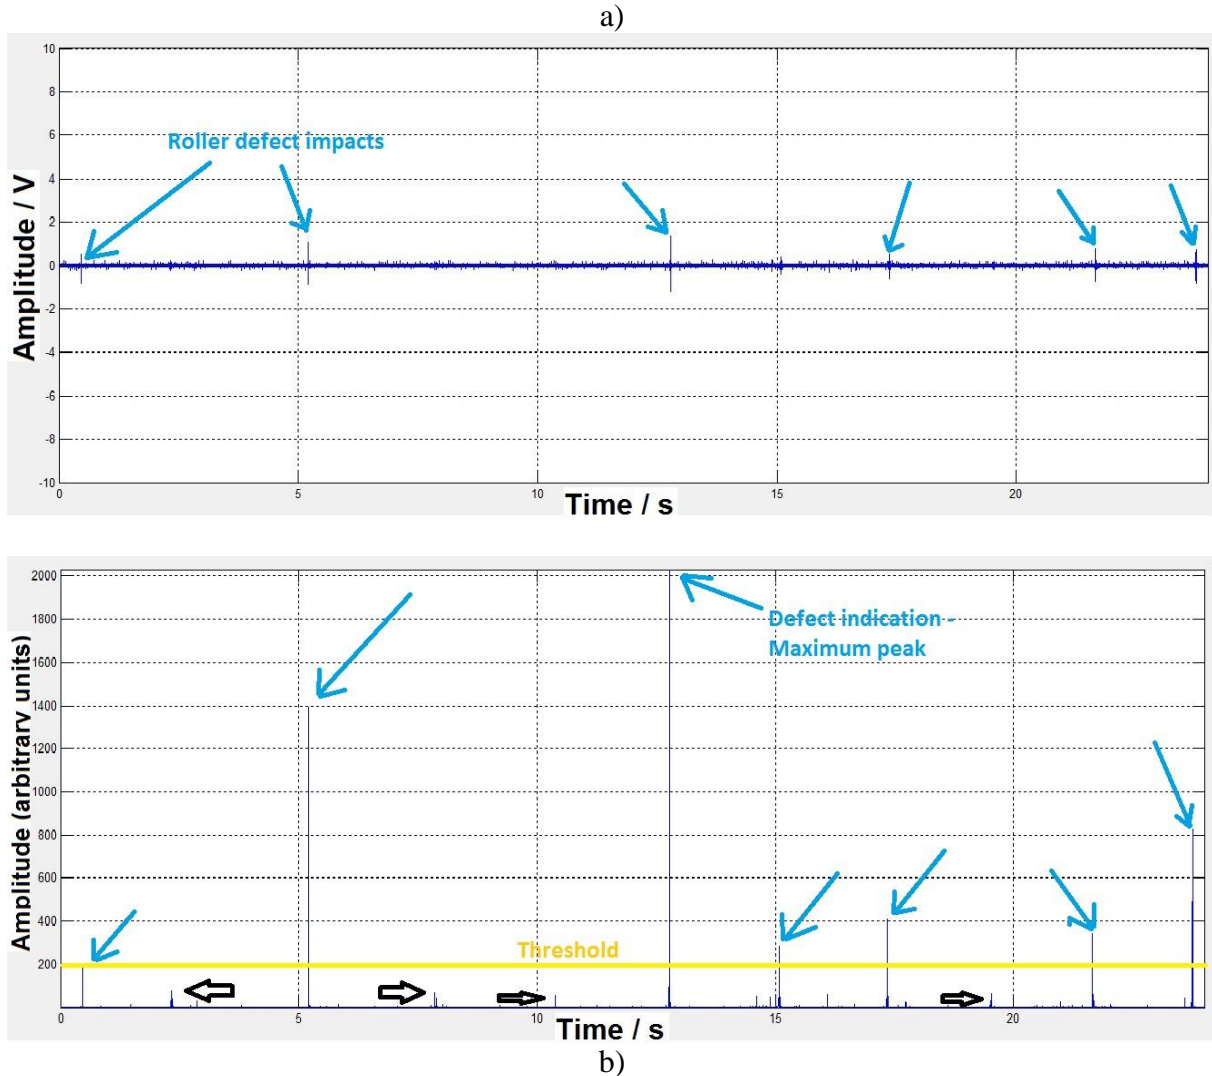
Figure 10: a) Raw AE data acquired from a bearing with a 4 mm roller defect and b) RMS processed results. Notice the amplitude of the strong RMS peaks.

Figure 10a shows the onboard AE measurement for a 4 mm roller defect which was artificially induced using a power tool. The signal appears to be slightly noisier than the healthy one. The peaks seen in the raw AE dataset correspond to the impact of the defective roller as the bearing rotates. By converting the raw data to normalised moving RMS we can see that a number of peaks are evident in the plot, some of which exceed significantly 200 units indicating the presence of a defect. Peaks no more than 200 units have been determined after the analysis of several tests in the field and laboratory to be associated with noise rather than actual defects. The highest peak for the 4 mm roller defect has maximum RMS

amplitude of 2000 units, well above the predefined threshold. The variability in the resulting moving RMS maximum peak per location should be taken into consideration. Although in the raw dataset amplitude variations seem to be smaller the energy of the impact is not the same and depends on the speed of the train as well as the quality of the rail track and the wheel. The more the bearing is loaded as it rotates the more energy will be released.

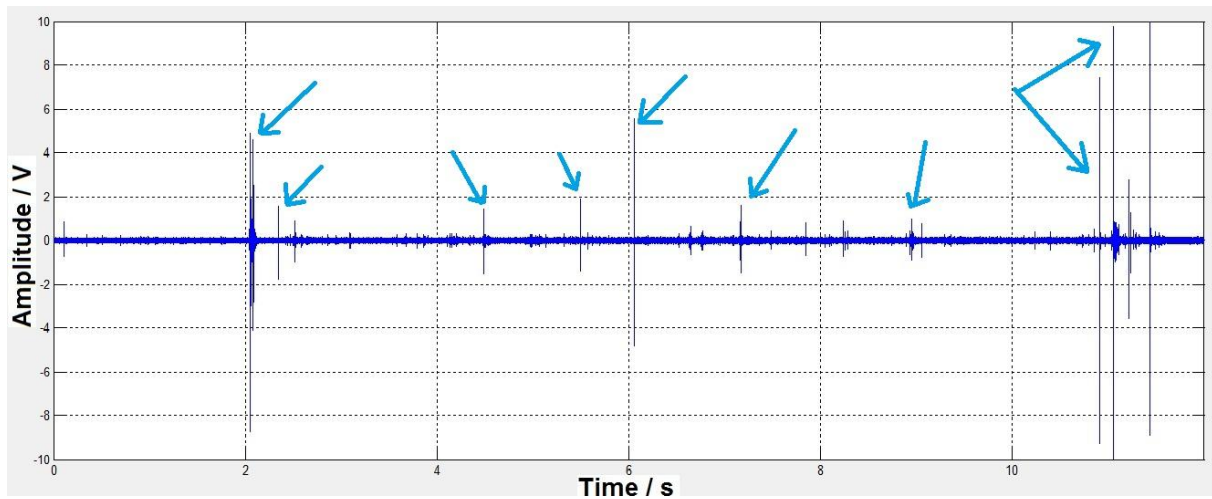
Figure 11: a) Raw AE data acquired from a bearing with a 8 mm roller defect and b) RMS processed results. Notice the amplitude of the strong RMS peaks which is much higher than the RMS for the 4mm roller.

Figure 11a presents the raw AE data and 11b the moving RMS from an 8mm roller defect. Note the increasing maximum peak amplitude (~5100 arbitrary units) of the RMS signal indicating the higher severity. However, the variability in each axle bearing rotation remains with some of the peaks falling even below the threshold limit despite the much higher amplitudes recorded in the raw signal. This is another indication that the amplitude is not sufficient indicator and the energy the signal carries need to be considered. Also in order to safely assess the severity of the signal we need to trend the maxima from several measurements in order to reach a reliable conclusion.

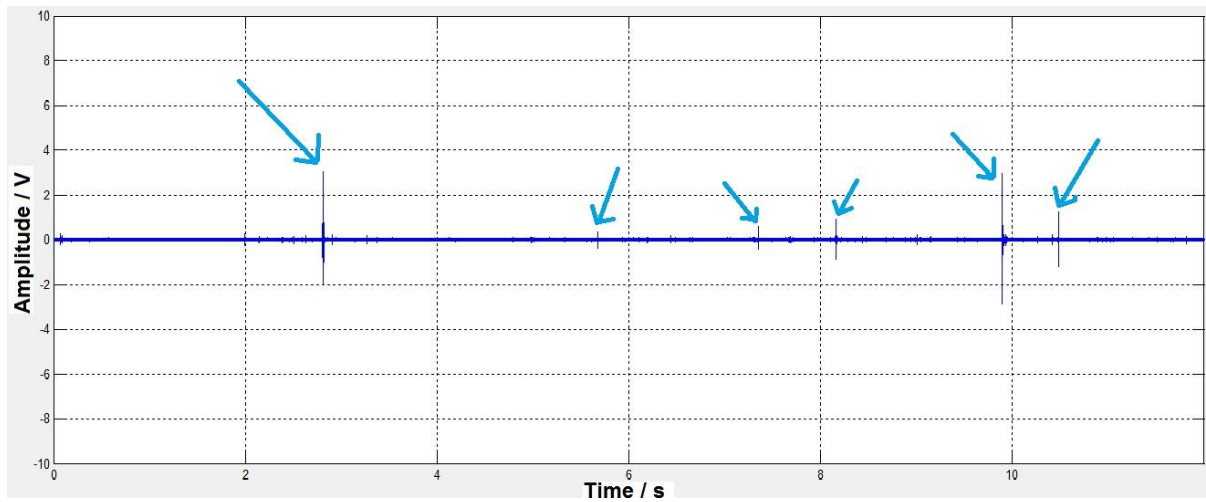
Figure 12: a) Raw data of 8 mm race defect and b) moving RMS processed results.

Figure 12a shows the raw AE data and 12b the moving RMS acquired from a bearing with an 8 mm race bearing defect. It is noticeable that the raw AE amplitude varies significantly from measurement to measurement but the moving RMS provides a consistent analysis method for evaluating the severity of the defects provided that the maxima are trended and compared.

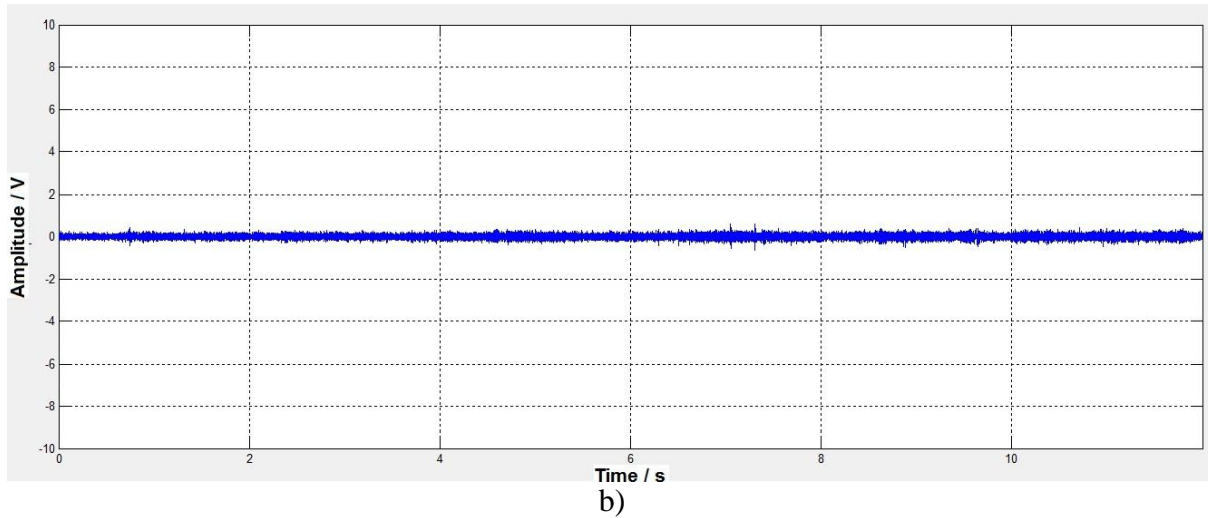
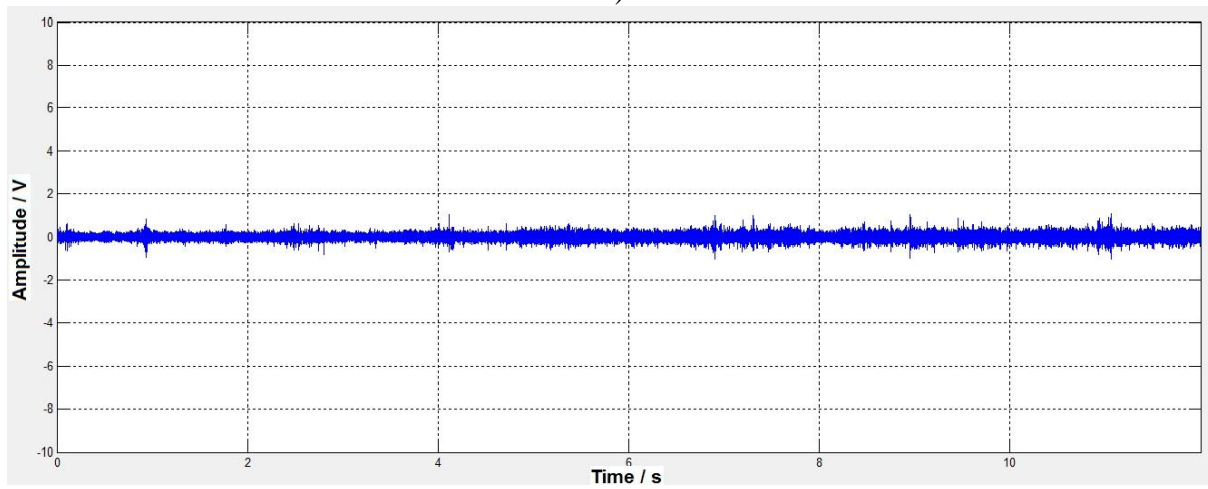
Figure 13: a) Raw acceleration for a healthy axle bearing and b) raw acceleration for an axle bearing containing a 2mm roller defect.

Figure 13a shows the raw vibration response for a healthy bearing and 13b for the axle bearing containing a 2 mm roller defect. The raw acceleration appears to be a bit more noisier for the defective axle bearing. However, it is not possible to arrive into safe conclusions by just looking into the raw measurements.

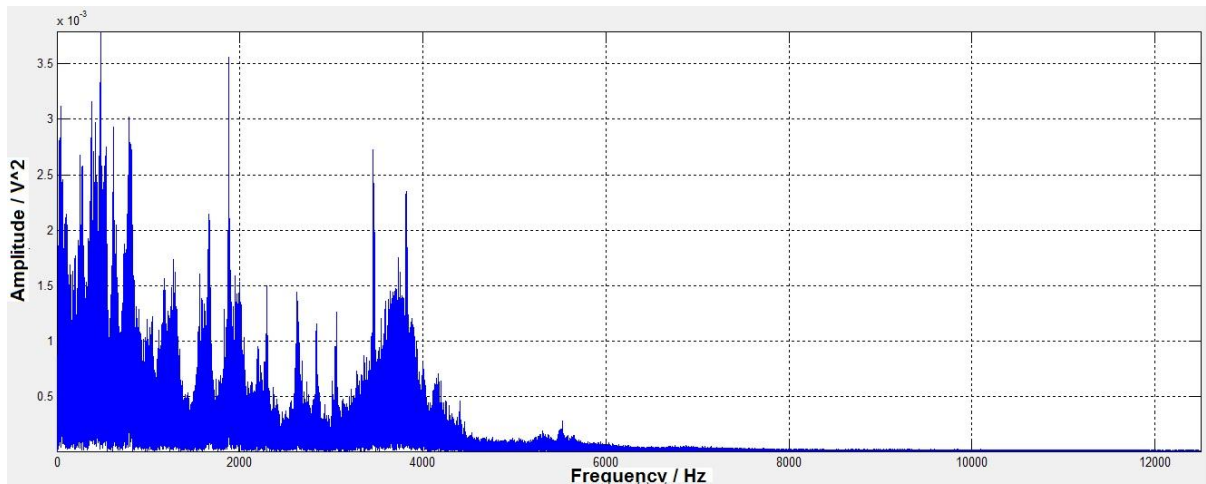
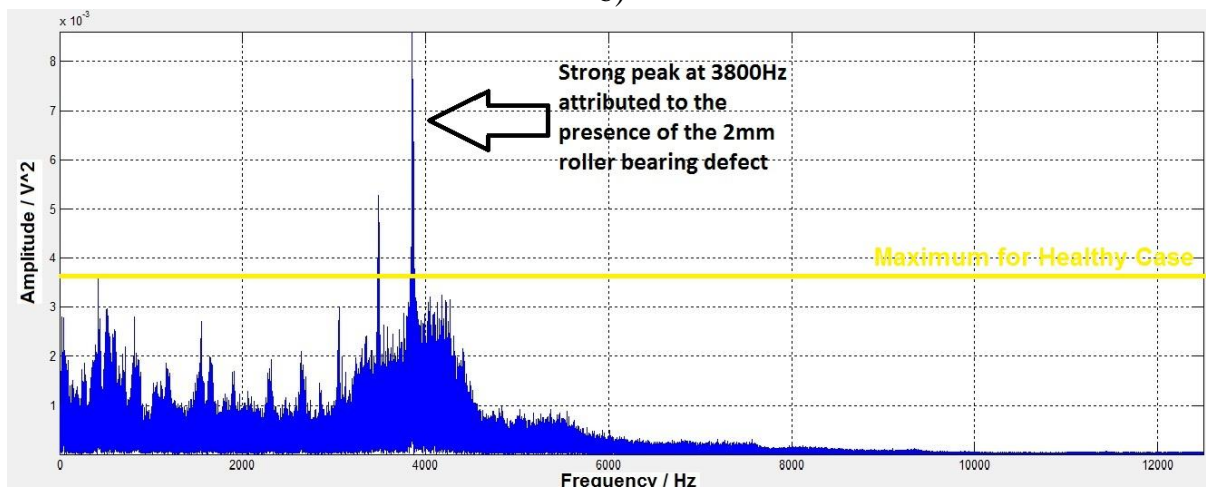
Figure 14: a) Power spectrum of the healthy axle bearing and b) power spectrum of the faulty axle bearing containing a 2 mm roller defect.

By converting the time-domain signal into frequency-domain using Fast Fourier Transform (FFT) it is evident that for the faulty axle bearing a considerably strong peak appears in the power spectrum plot in figure 14b at approximately 3800 Hz. This peak also exists in the healthy axle bearing power spectrum in figure 14a but its magnitude is significantly lower. The repeated measurements carried out on both axle bearings indicated the persistence of the strong peak at 3900 Hz in the power spectrum of the signal for the defective axle bearing. This suggests that the significant increase in the 3800 Hz peak is likely to be associated with the roller defect present. However, it is not possible to evaluate the severity of the defect using the vibration measurements and through this analysis it is only possible to qualitatively evaluate the possible presence of a problem in the axle bearing under evaluation.

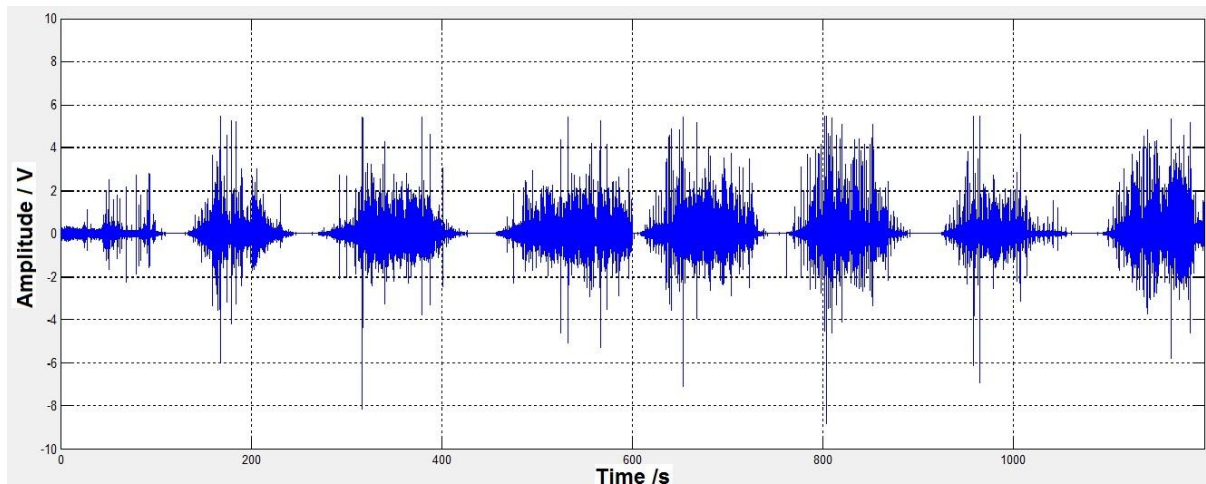
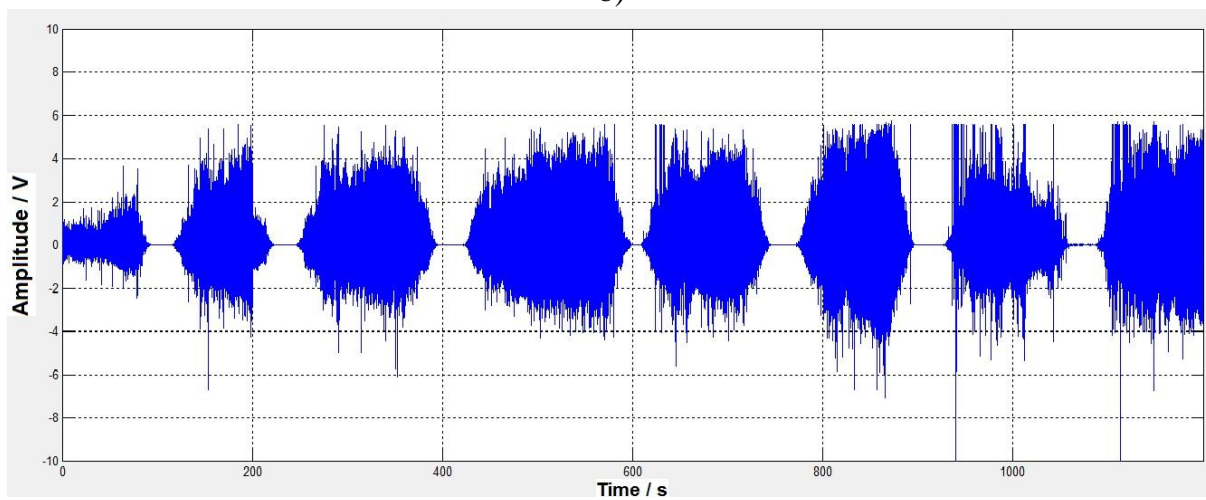
Figure 15: a) Raw vibration data for healthy wheel and b) raw vibration data for defective wheel.

During the EMU trials in Portugal, acceleration measurements were collected for a wheel free of defects and a defective wheel containing shelling on the tread surface. The average train speed during tests was 75 km/h or 20.70 m/sec. The plot in figure 15a shows the raw vibration signal for the healthy wheel and 15b for the wheel in the deteriorated condition. Although the raw vibration plots generally differ in each wheel condition, it is not sufficient to arrive in a safe conclusion since the vibration data will differ from wheel to wheel regardless of their actual condition. It is crucial to be able to identify from the vibration measurements the origin of the fault. A flat or spalling should give different pattern from a bearing defect. Approaches based on peak to peak levels alone should be considered more dependable on the measurement conditions as load, speed, wheel profile quality and rail track quality.

Thus it is impossible to assess the severity of the defects present on the damaged wheel based on the raw data alone. For this reason further analysis was carried out using moving RMS, spectral analysis (FFT) of the raw signal and spectral analysis of the demodulated signal (FFT of the envelope of the signal).

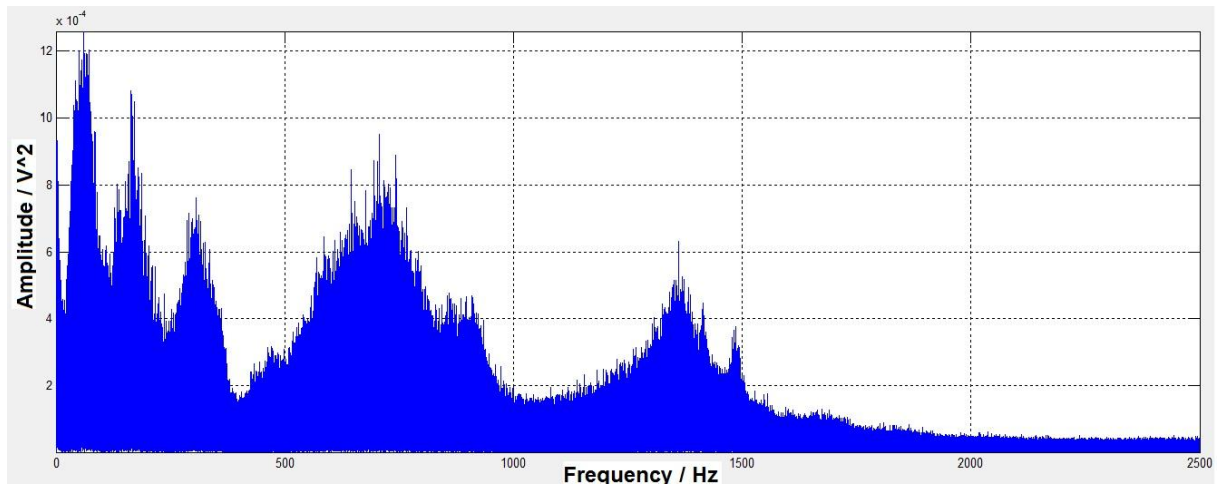
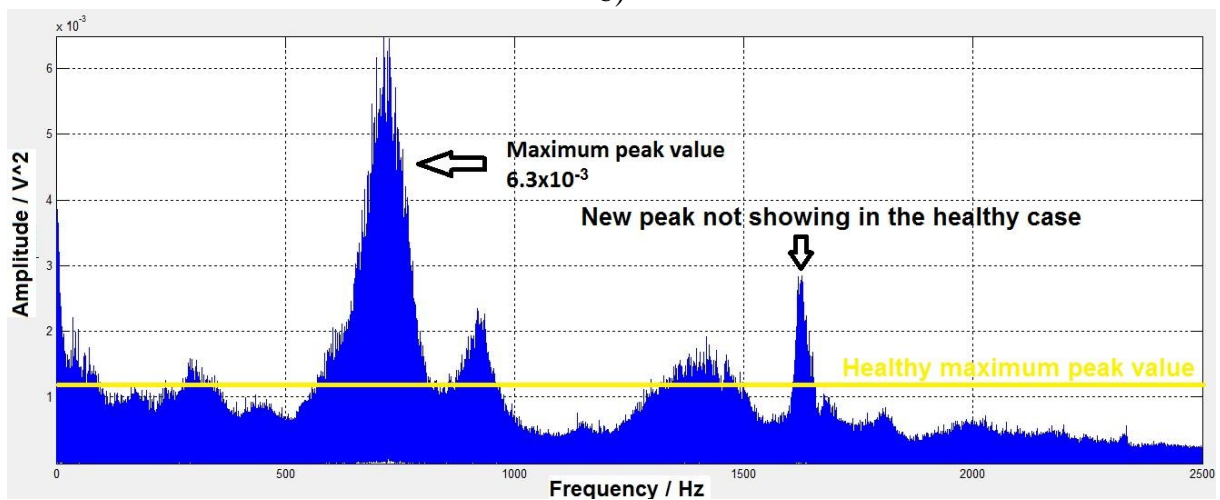
Figure 16: a) Vibration power spectrum for the healthy wheel and b) vibration power spectrum for the defective wheel.

Figure 16 shows the power spectra for the healthy (16a) and defective wheel (16b). A new significant peak is evident at approximately 1600 Hz in the power spectrum for the defective wheel which is not present in the power spectrum of the healthy bearing. Furthermore, the peaks at approximately 700 Hz and 900 Hz are much stronger in the power spectrum of the defective bearing in comparison to the one for the healthy bearing indicating a potential problem as expected which indeed indicates the presence of a problem but does not provide an indication of the fault's origin.

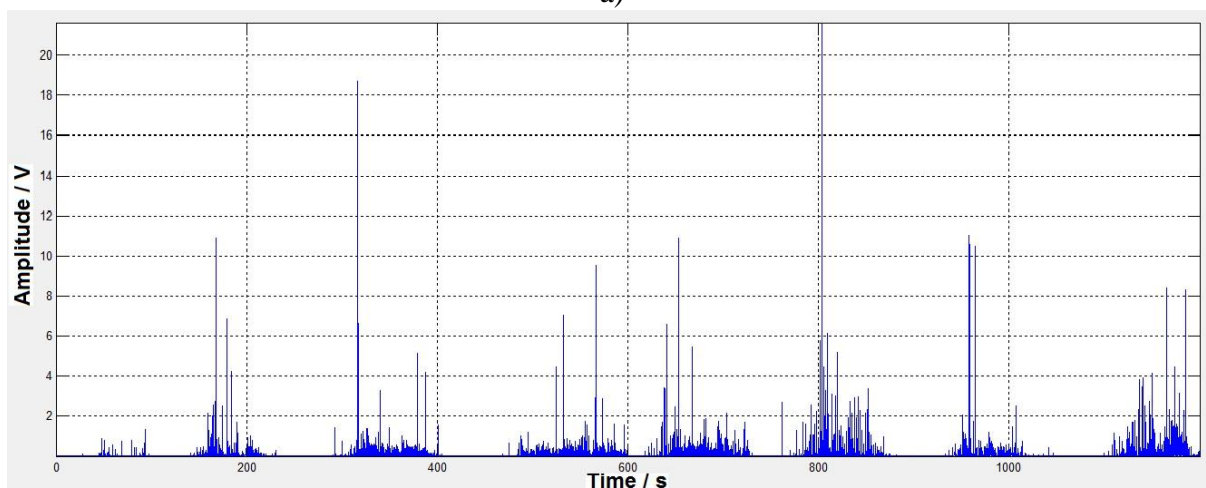
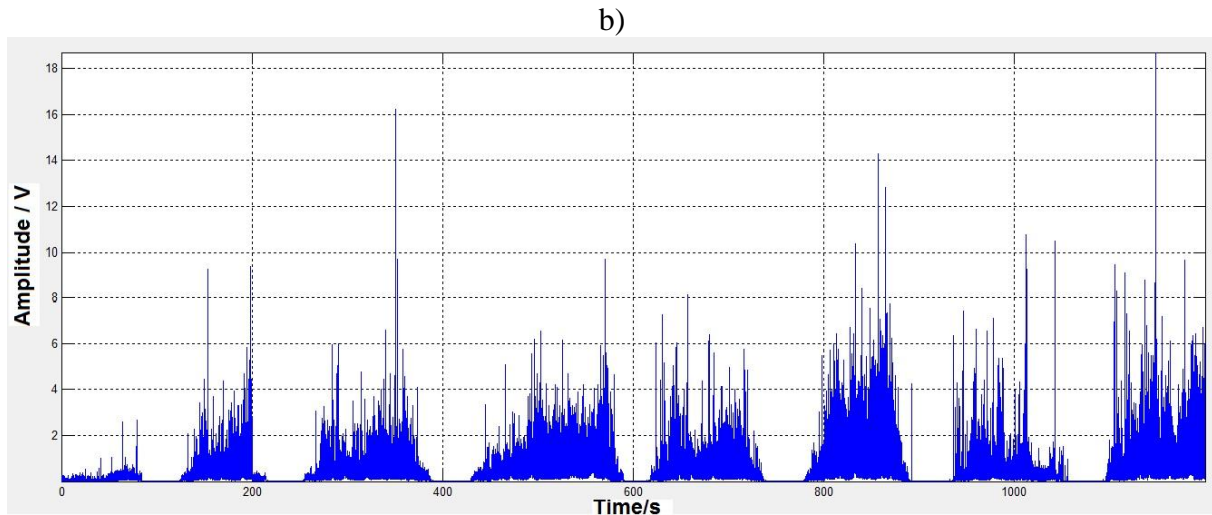
Figure 17: a) Moving RMS for healthy wheel and b) moving RMS for defective wheel.

The plots in figure 17 show the moving RMS of the raw vibration signal for the healthy (17a) and defective wheel (17b). Although in the case of the defective wheel the moving RMS is far more noisier due to the vibrations caused by the defective tread area of the damaged wheel than the moving RMS of the healthy wheel it is not possible to ascertain safely the defect and its nature. More in depth analysis is required.

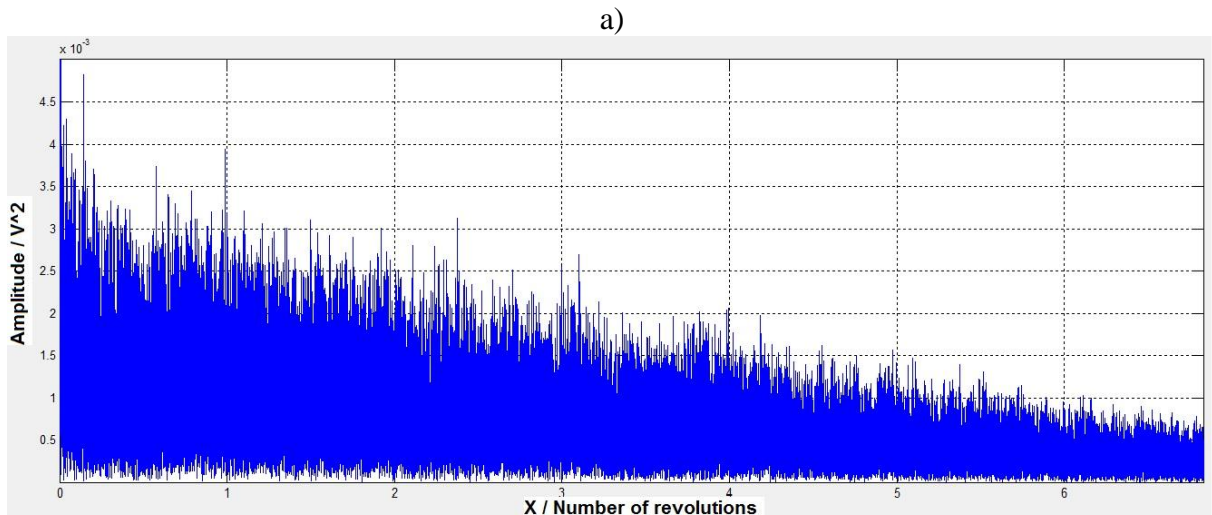
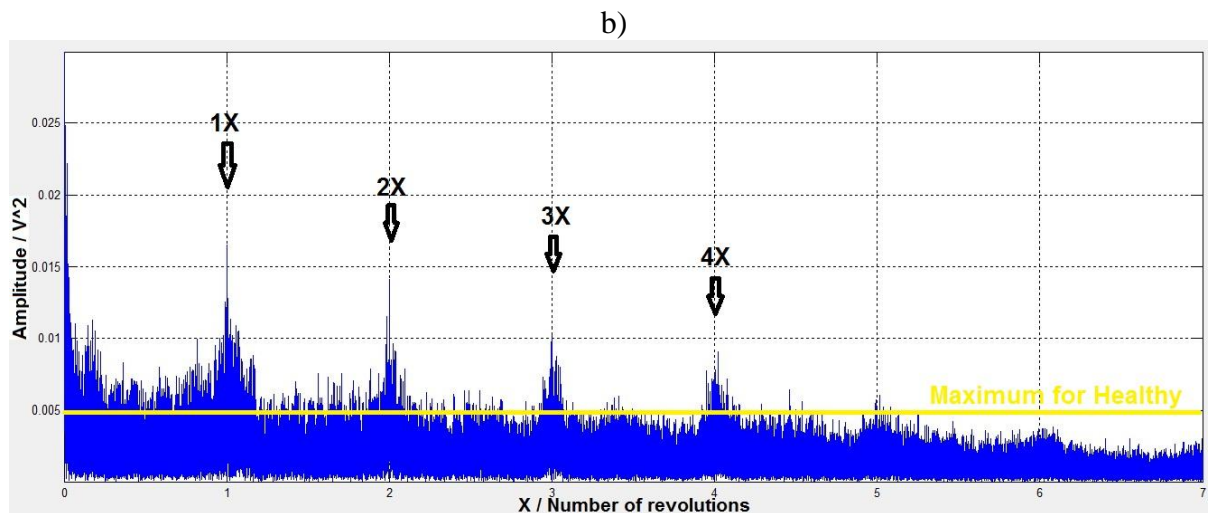
Figure 18: a) Demodulated power spectrum for the healthy wheel showing no harmonics and b) demodulated power spectrum for the defective wheel showing clear evidence of multiple harmonics up to 4X. Note also the significant difference in the amplitude of the two signals.

Since shelling is expected to impact on the rail during each wheel revolutions or 1X the low frequency power spectrum and harmonics should be employed in order to identify this specific fault. The plots in figure 18 show the low frequency demodulated power spectrum of the acceleration signal up to 7 wheel revolutions (7X) for both the healthy (18a) and defective (18b) wheels. The demodulated power spectrum signal in figure 18b shows clearly the 1X peak and associated harmonics up to 4X for the defective wheel indicating the presence of a fault on the tread. In the plot of figure 18a these harmonics are not present for the healthy wheel. Thus, this analysis clearly identifies wheel faults and a clear separation between healthy and deteriorated condition has been achieved. It is possible to relate the result directly to any wheel problems present thanks to the multiple harmonics showing up if the train speed is taken into account.
